**Flood Control Project Maintenance  
Levee Inspections**

**Fall 2016 Levee Maintenance Deficiency Summary Report**

**Sacramento River Basin**

<b>ST0003</b>	Overall LMA Rating	Total LMA Miles	* Overall LMA Threshold Percent is less than 10.00%; however, U Rated Miles are present, so the Overall LMA Rating is M instead of A.					
<b>Sutter Maintenance Yard East Levee Sacramento River</b>	<b>M *</b>	<b>26.82</b>						
Rated Item	Maintenance Deficiency				Enforcement		Design & System Obsolescence	
	M Miles	U Miles	M + 4U Miles	Threshold %	M Miles	U Miles	M Miles	U Miles
<i>Earthen Levee</i>								
Vegetation	0.83		0.83	3.10%	0.01			
Trim / Thin Trees	0.07		0.07	0.26%				
Encroachments					1.83	0.06		
Animal Control	0.08	0.01	0.12	0.45%				
Slope Stability	0.05		0.05	0.19%				
Erosion / Bank Caving	0.02		0.02	0.08%				
<i>Supplemental</i>								
2015 USACE Erosion Survey, DRAFT	0.36		0.36	1.34%				
DWR UCIP Field Study					0.38	0.11		
<i>LMA Totals:</i>	1.41	0.01	1.45	5.41% *	2.22	0.17	0.00	0.00
<b>Unit No. 01 Sacramento River LB</b>	Overall Unit Rating	Total Unit Miles	* Overall Unit Threshold Percent is less than 10.00%; however, U Rated Miles are present, so the Overall Unit Ra

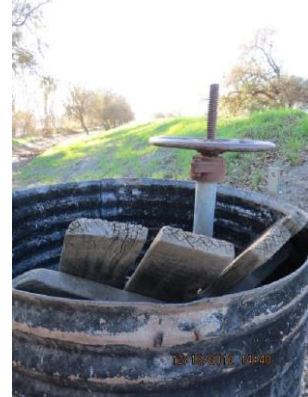
Photo 2 of 2 : UCIP\_FA\_2016\_50629\_46981.jpg

Comment Code					
Inspector Comment					
FS_ID:50629 DS_ID:17319 EP_NO: 9527 Repair Type: Urgent Crossing Status: Found UCIP Comments: 11/7/2016 No LS repairs have been made yet. (DWR Sutter Yard- AFreitag)6/6/2016 New flow meter installed on WS. Walkway to access the pump is overgrown with vegetation and not accessible. (DWR Sutter Yard - afreitag) 4/5/2016 Caved-in slope on landside (LS) not yet repaired. Leaky pipe marker gone. Per Bob Duffey (DWR FPIIB inspector), pipe will be replaced by owner next year. If not, will go to CVFPB enforcement. (DWR UCIP - kfazel)4/6/2015 Pipe leaks during times of High water. Slope damage still present. Needs a more detailed inspection to find the leak. (DWR Sutter Yard - afreitag)6/30/2014 Same as last inspection. (DWR Sutter Yard - afreitag)12/30/2013 Same as last inspection. (DWR Sutter Yard - afreitag)7/29/2013 Pipe does not appear to be abandoned. On the WS it appears that a smaller pipe was sleeved into the 18in. Pipe and then the difference capped and welded. Pump was not running at time of inspection but LS ditch near outlet was wet. LS slope damage and leaky pipe marker are still present. (DWR Sutter Yard - afreitag)12/13/2012 Abandoned and plugged/capped steel pipe on WS berm. DWR leaky pipe marker on LS (12-3). Slope failure on LS. Needs capping of LS steel pipe after detailed investigation. (DWR UCIP - pamatya) FIELD_STRUCT_DESC: 18-inch steel irrigation pipe through the levee, 12.5 feet below the crown. Gate valve on the waterside (WS). Vertical pump on the WS bank. Flow meter on the WS. (Automatic Board Order (ABO) issued as Permit No. 9527, 1974 - Butte Creek Farms) [Additional Reference(s): DWR Levee Log, 2002. USACE Sacramento O&M Manual 136, March 1960 (HLM 1.1)]. FS Date: 11/7/2016 2:37:24 PM

Waterside view: CMP riser with slide gate

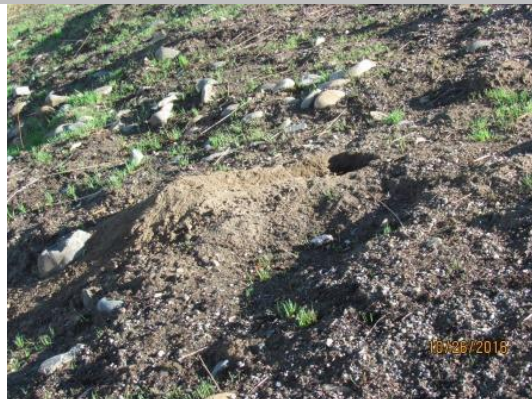
Photo 1 of 1 : FA\_2016\_ST0003\_264\_83\_20161104\_00125.jpg

LM Start	1.62	Rating **	M	Issue No.	83
LM End	1.62	Issue Type +	Ma	Location *	LS
Category	Earthen Levee			GPS Latitude/Longitude	
				Start	End
Item	Animal Control			39.190835 °	39.190835 °
				-121.960628 °	-121.960628 °
DWR ID	DWR_ST0003_01_f_2016_83				
Comment Code					
A1 : Exterminate rodents and backfill and compact or grout burrows.					
Inspector Comment

View of the rodent holes along the landside slope.

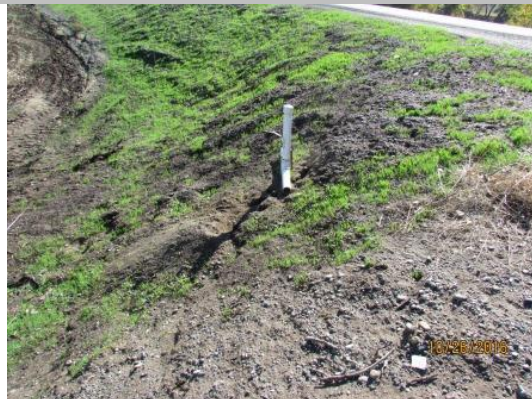
Photo 1 of 1 : FA\_2016\_ST0003\_264\_84\_20161104\_00126.jpg

LM Start	2.07	Rating **	M	Issue No.	84
LM End	2.07	Issue Type +	Ma	Location *	LS
Category	Earthen Levee			GPS Latitude/Longitude	
				Start	End
Item	Animal Control			39.187776 °	39.187776 °
				-121.967516 °	-121.967516 °
DWR ID	DWR_ST0003_01_f_2016_84				
Comment Code					
A1 : Exterminate rodents and backfill and compact or grout burrows.					
Inspector Comment

View of the rodent holes along the landside slope.

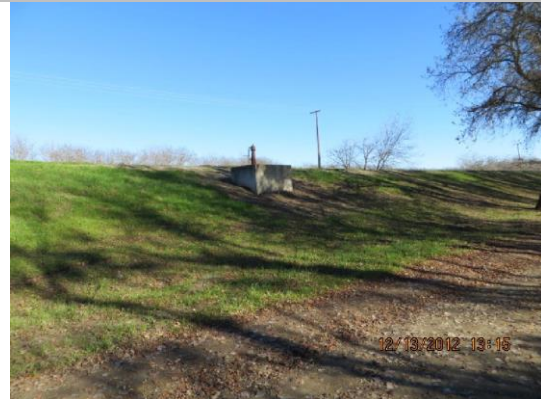
Photo 1 of 2 : UCIP\_FA\_2016\_50635\_47027.jpg

Comment Code					
Inspector Comment					
FS_ID:50635 DS_ID:17309 EP_NO: 9541 Repair Type: Non-Urgent Crossing Status: Found UCIP Comments: 11/7/2016 LS culvert measured to be 30"wide X 30"tall. WS end is not vidible so could not be measured. (DWR Sutter Yard- AFreitag)6/6/2016 Cannot locate the WS headwall/flapgate. Appears to have been silted over.4/6/2015 Same as last inspection. Concrete surg box on WS. Flap gate in concrete "U" headwall at the waterward end- not found.6/30/2014 Same as last inspection.12/30/2013 Same as last inspection.7/29/2013 Same as last inspection. FIELD_STRUCT_DESC: 30-inch reinforced concrete box drainage culvert through the levee, 14.3 feet below the crown. 30-inch corrugated metal pipe connects concrete culvert from slide gate out to flap gate on the waterside (WS) end. Slide gate in a concrete riser on the waterside (WS) slope. (Automatic Board Order (ABO) issued as Permit No. 9541, 1974 - Wilbur, McGowan, Zinke). [Additional Reference(s): DWR Levee Logs, 2002. USACE Sacramento O&M Manual 136, March 1960 (HLM 2.49)]. FS Date: 11/7/2016 2:57:48 PM

Waterside view: overview- concrete surg tank

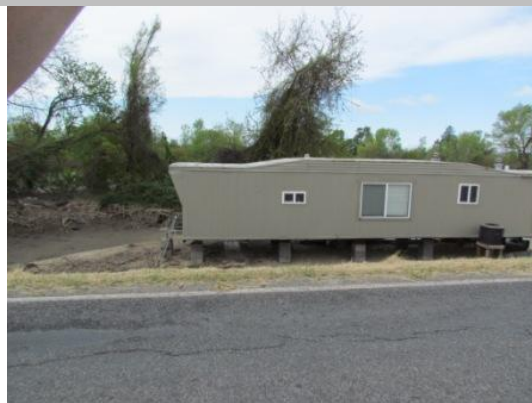
Photo 1 of 1 : FA\_2016\_ST0003\_264\_11\_20160823\_00006.jpg

LM Start	3.54	Rating **	M	Issue No.	11
LM End	3.81	Issue Type +	En	Location *	WS
Category	Earthen Levee			GPS Latitude/Longitude	
				Start	End
Item	Encroachments			39.200007 °	39.203634 °
				-121.985257 °	-121.982977 °
DWR ID	DWR_ST0003_01_f_2016_11				
Comment Code					
BU : Building					
Inspector Comment

View of a trailer next to the waterside toe.

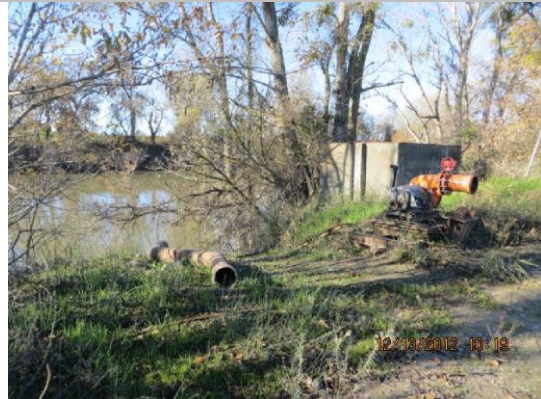
Photo 2 of 2 : UCIP\_FA\_2016\_50801\_47067.jpg

FIELD\_STRUCT\_DESC: 10-inch asphalt coated steel irrigation pipe through the levee, 5 feet below the crown. Siphon breaker off the landside (LS) shoulder. Motor and pump on the waterside (WS) at water level. The pipe is open through the WS slope with an air vent on the apex of the pipe. Another piece of pipe, found laying on the WS slope in 2016, is used to connect the 10-inch open pipe to the pump at the water level. A flexible suction line for the pump found in the water above the pump and motor. Abandoned 16-inch crossing (DSID 17326) associated with this permit also at this location. Pipe through the LS slope is steel with polyvinyl chloride (PVC) pipe installed at its flange; PVC pipe partially penetrates the LS slope. Flow meter installed to PVC pipe section on LS. (Permit No. 9501-A, 1978 - Mayfair Packing, Inc.).  
[Additional Reference(s): DWR Levee Log, 2002].  
FS Date: 11/21/2016 7:33:17 AM

Waterside view: overview of pump and abandoned pipe

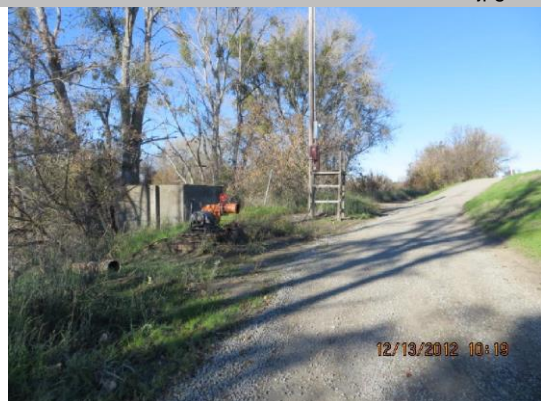
Photo 2 of 2 : UCIP\_FA\_2016\_50802\_47079.jpg

Waterside view: overview

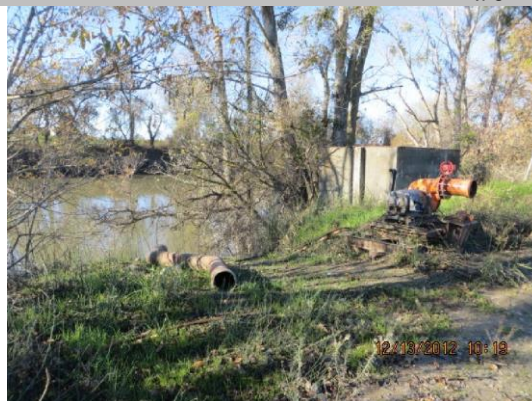
Photo 2 of 2 : UCIP\_FA\_2016\_50803\_47086.jpg

Waterside view: overview of concrete surge box

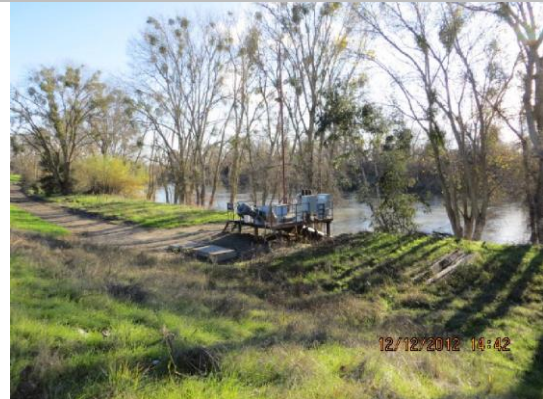
Photo 1 of 2 : UCIP\_FA\_2016\_50804\_47092.jpg

FIELD\_STRUCT\_DESC: 24-inch asphalt coated steel irrigation pipe, 4 feet below the crown. Slant pump on a steel platform on the waterside (WS) berm. Siphon breaker on the apex of the pipe and off the levee crown on the landside (LS). 2 shut-off (butterfly) valves off the LS toe. Power pole with electrical conduit and panel on the LS toe. Pipe appears to run diagonally through the levee and discharges into a ditch off the LS toe. Gate structure on the outlet at the ditch. (Automatic Board Order (ABO) issued as Permit No. 9501, 1974 - Mayfair Farms, Inc.). Slant pump installed under Permit No. 10935, 1975 - Pires. [Additional Reference(s): DWR Levee Log, 2002].  
FS Date: 11/21/2016 7:37:06 AM

Waterside view: overview

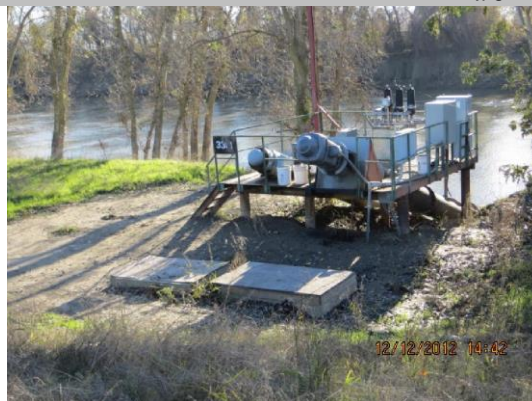
Photo 2 of 2 : UCIP\_FA\_2016\_50804\_47091.jpg

FIELD\_STRUCT\_DESC: 24-inch asphalt coated steel irrigation pipe, 4 feet below the crown. Slant pump on a steel platform on the waterside (WS) berm. Siphon breaker on the apex of the pipe and off the levee crown on the landside (LS). 2 shut-off (butterfly) valves off the LS toe. Power pole with electrical conduit and panel on the LS toe. Pipe appears to run diagonally through the levee and discharges into a ditch off the LS toe. Gate structure on the outlet at the ditch. (Automatic Board Order (ABO) issued as Permit No. 9501, 1974 - Mayfair Farms, Inc.). Slant pump installed under Permit No. 10935, 1975 - Pires. [Additional Reference(s): DWR Levee Log, 2002].  
FS Date: 11/21/2016 7:37:06 AM

Waterside view: overview of pump station

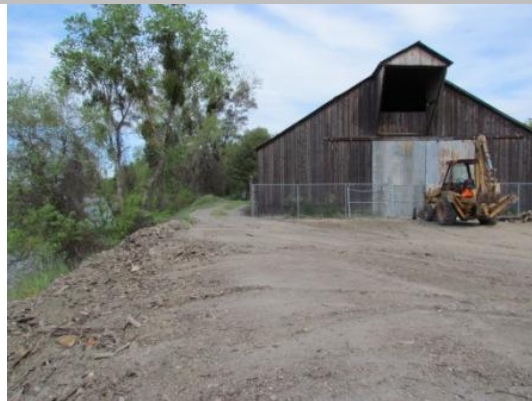
Photo 1 of 1 : FA\_2016\_ST0003\_264\_12\_20160823\_00007.jpg

LM Start	4.72	Rating **	M	Issue No.	12
LM End	4.72	Issue Type +	En	Location *	CR
Category	Earthen Levee			GPS Latitude/Longitude	
				Start	End
Item	Vegetation			39.213265 °	39.213265 °
				-121.991672 °	-121.991672 °
DWR ID	DWR_ST0003_01_s_2012_12				
Comment Code					
V6 : Landscaping					
Inspector Comment

View of the barn on the large crown of the levee.

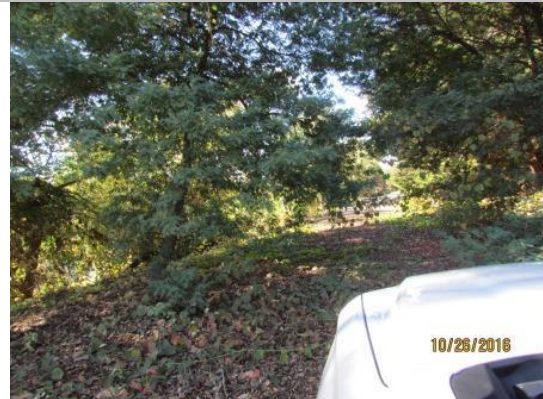
Photo 1 of 1 : FA\_2016\_ST0003\_264\_104\_20161104\_00128.jpg

LM Start	4.76	Rating **	M	Issue No.	104
LM End	4.76	Issue Type +	Ma	Location *	CR
Category	Earthen Levee			GPS Latitude/Longitude	
				Start	End
Item	Trim / Thin Trees			39.213650 °	39.213650 °
				-121.992219 °	-121.992219 °
DWR ID	DWR_ST0003_01_f_2016_104				
Comment Code					
T1 : Trim trees to at least five feet above ground level.					
Inspector Comment

View of the overgrown trees along the crown.

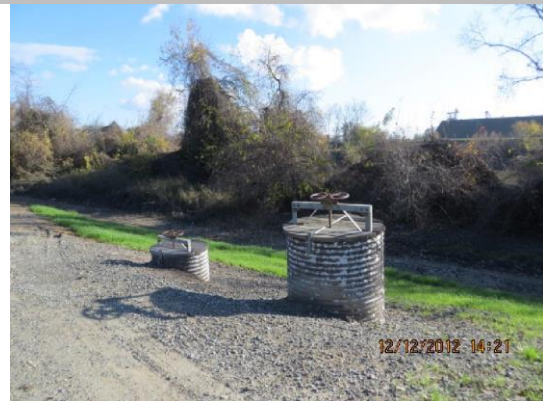
Photo 1 of 2 : UCIP\_FA\_2016\_50806\_47107.jpg

Comment Code					
Inspector Comment					
FS_ID:50806 DS_ID:17287 EP_NO: 9520 Repair Type: Non-Urgent Crossing Status: Indicator Found UCIP Comments: 11/7/2016 appears abandoned and should be done so properly. (DWR Sutter Yard- A Freitag)6/6/2016 Appears to be an abandoned crossing.4/6/2015 Same as last inspection. Still appears abandoned. A concrete standpipe and a CMP riser on WS. It seems abandoned and if so should be done so properly.6/30/2014 Same as last inspection.12/30/2013 Same as last inspection.7/29/2013 Same as last inspection. FIELD_STRUCT_DESC: *ABANDONED* 24-inch corrugated metal drainage pipe through the levee, 17 feet below the crown, not found in 2015. Slide gate in a corrugated metal pipe (CMP) riser on the waterside (WS) slope, found in 2015. Pump on the WS bank and concrete standpipe on the WS berm, found in 2015. 18-inch concrete pipe from standpipe at WS toe. Pipe discharges into a field on the landside (LS), not found in 2015. (Automatic Board Order (ABO) issued as Permit No. 9520, 1974 - Arnold). [Additional Reference(s): DWR Levee Log, 2002. USACE Sacramento O&M Manual 136, March 1960 (HLM 4.99)]. FS Date: 11/21/2016 7:38:39 AM

Waterside view: overview

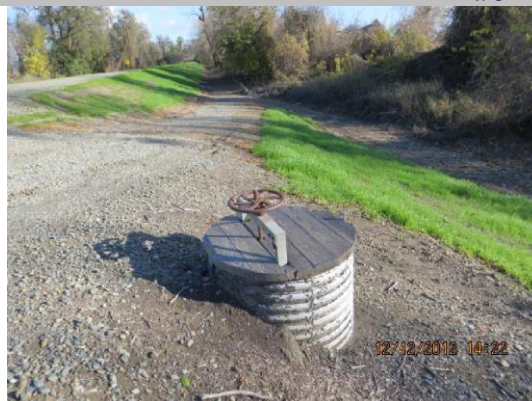
Photo 2 of 2 : UCIP\_FA\_2016\_50806\_47106.jpg

Comment Code					
Inspector Comment					
FS_ID:50806 DS_ID:17287 EP_NO: 9520 Repair Type: Non-Urgent Crossing Status: Indicator Found UCIP Comments: 11/7/2016 appears abandoned and should be done so properly. (DWR Sutter Yard- AFreitag)6/6/2016 Appears to be an abandoned crossing.4/6/2015 Same as last inspection. Still appears abandoned. A concrete standpipe and a CMP riser on WS. It seems abandoned and if so should be done so properly.6/30/2014 Same as last inspection.12/30/2013 Same as last inspection.7/29/2013 Same as last inspection. FIELD_STRUCT_DESC: *ABANDONED* 24-inch corrugated metal drainage pipe through the levee, 17 feet below the crown, not found in 2015. Slide gate in a corrugated metal pipe (CMP) riser on the waterside (WS) slope, found in 2015. Pump on the WS bank and concrete standpipe on the WS berm, found in 2015. 18-inch concrete pipe from standpipe at WS toe. Pipe discharges into a field on the landside (LS), not found in 2015. (Automatic Board Order (ABO) issued as Permit No. 9520, 1974 - Arnold). [Additional Reference(s): DWR Levee Log, 2002. USACE Sacramento O&M Manual 136, March 1960 (HLM 4.99)]. FS Date: 11/21/2016 7:38:39 AM

Waterside view: CMP riser with slide gate

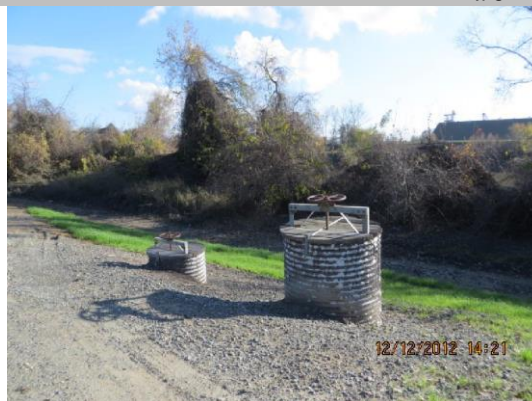
Photo 1 of 2 : UCIP\_FA\_2016\_50807\_47112.jpg

Waterside view: CMP riser with slide gate (right)

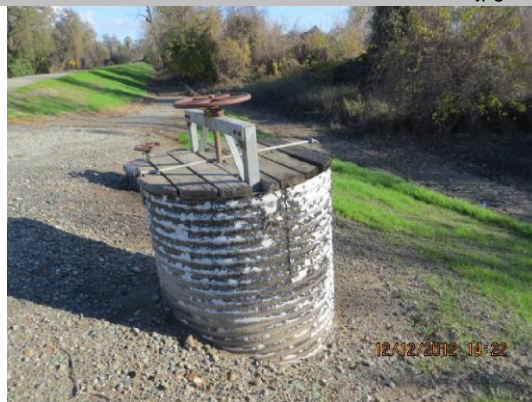
Photo 2 of 2 : UCIP\_FA\_2016\_50807\_47111.jpg

Waterside view: CMP riser with slide gate

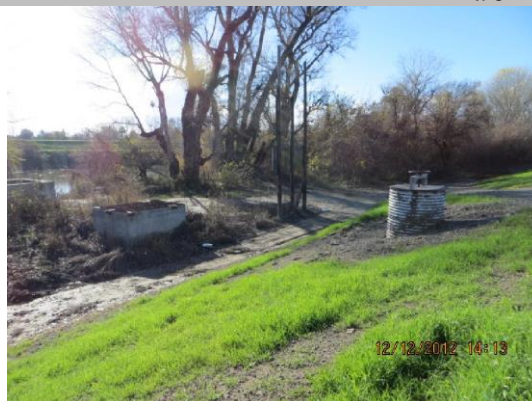
Photo 1 of 2 : UCIP\_FA\_2016\_50808\_47115.jpg

FIELD\_STRUCT\_DESC: \*ABANDONED\* 36-inch corrugated metal irrigation pipe through the levee, 18.4 feet below the crown, not found in 2016. Slide gate in a corrugated metal pipe (CMP) riser on the waterside (WS) shoulder, found in 2016. Pump and concrete pump pit on the WS bank, found in 2013. Concrete surge box on the WS berm, found in 2016. Pipe discharges into an irrigation ditch on the landside (LS). (Levee Log references Permit No. 2904, 1958 - Butte Creek Farms, Inc. This permit authorizes an existing pump house and makes no mention of this pipe and its appurtenances). [Additional Reference(s): DWR Levee Log, 2002. USACE Sacramento O&M Manual 136, March 1960 (HLM 5.00)]  
FS Date: 11/21/2016 7:51:40 AM

Waterside view: overview

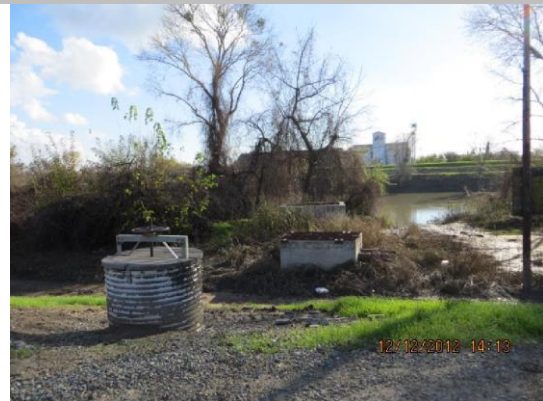
Photo 2 of 2 : UCIP\_FA\_2016\_50808\_47113.jpg

FIELD\_STRUCT\_DESC: \*ABANDONED\* 36-inch corrugated metal irrigation pipe through the levee, 18.4 feet below the crown, not found in 2016. Slide gate in a corrugated metal pipe (CMP) riser on the waterside (WS) shoulder, found in 2016. Pump and concrete pump pit on the WS bank, found in 2013. Concrete surge box on the WS berm, found in 2016. Pipe discharges into an irrigation ditch on the landside (LS). (Levee Log references Permit No. 2904, 1958 - Butte Creek Farms, Inc. This permit authorizes an existing pump house and makes no mention of this pipe and its appurtenances). [Additional Reference(s): DWR Levee Log, 2002. USACE Sacramento O&M Manual 136, March 1960 (HLM 5.00)]  
FS Date: 11/21/2016 7:51:40 AM

Waterside view: CMP riser and surge box

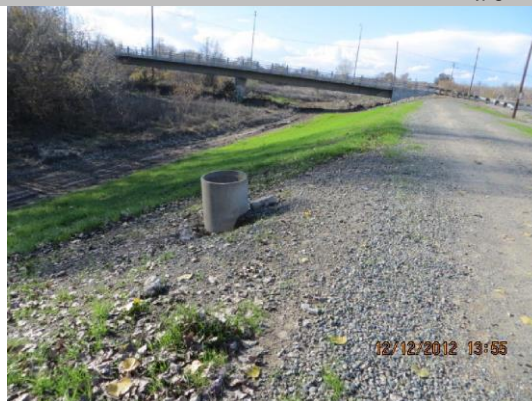
Photo 1 of 2 : UCIP\_FA\_2016\_50810\_47127.jpg

Waterside view: concrete pipe riser with gate valve

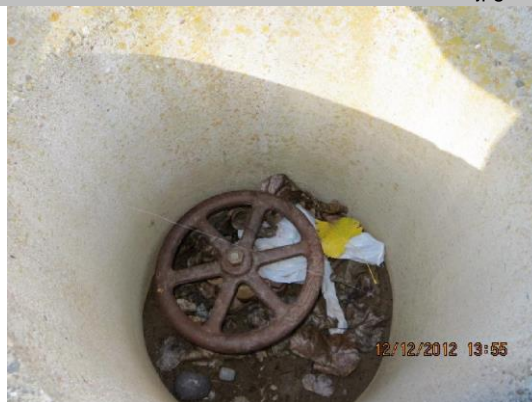
Photo 2 of 2 : UCIP\_FA\_2016\_50810\_47126.jpg

Waterside view: buried gate valve in concrete pipe riser

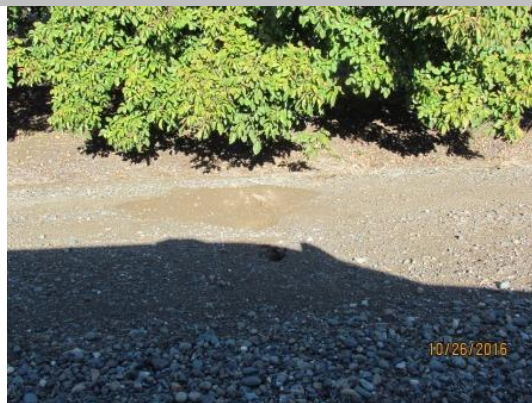
Photo 1 of 1 : FA\_2016\_ST0003\_264\_101\_20161104\_00129.jpg

LM Start	5.33	Rating **	M	Issue No.	101
LM End	5.33	Issue Type +	Ma	Location *	LS
Category	Earthen Levee			GPS Latitude/Longitude	
				Start	End
Item	Animal Control			39.216560 °	39.216560 °
				-122.002054 °	-122.002054 °
DWR ID	DWR_ST0003_01_f_2016_101				
Comment Code					
A3 : No rodents visible, but rodent burrows visible; need to backfill and compact or grout burrows.					
Inspector Comment

View of the rodent holes along the landside slope.

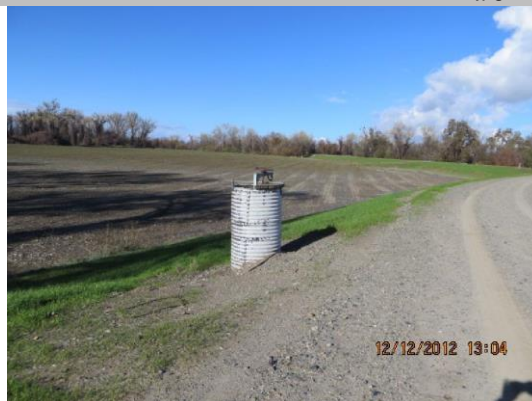
Photo 1 of 2 : UCIP\_FA\_2016\_50548\_47158.jpg

LM Start	<b>6.40</b>	Rating **	M	Issue No.	<b>107 (cont)</b>
LM End	<b>6.40</b>	Issue Type +	En	Location *	LS

Waterside view: CMP riser with slide gate

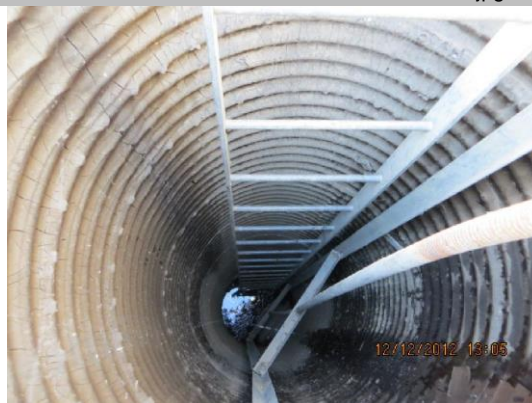
Photo 2 of 2 : UCIP\_FA\_2016\_50548\_47156.jpg

Waterside view: inside CMP riser

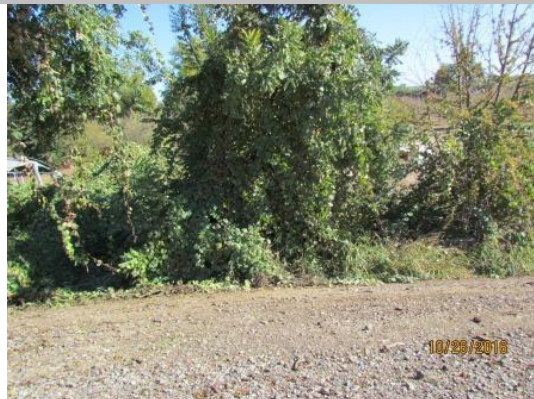
Photo 1 of 1 : FA\_2016\_ST0003\_264\_99\_20161104\_00131.jpg

LM Start	6.47	Rating **	M	Issue No.	99
LM End	6.47	Issue Type +	Ma	Location *	LS
Category	Earthen Levee			GPS Latitude/Longitude	
				Start	End
Item	Vegetation			39.224719 °	39.224719 °
				-121.998623 °	-121.998623 °
DWR ID	DWR_ST0003_01_f_2016_99				
Comment Code					
V2 : Remove the wild growth other than native grasses from the levee slopes.					
Inspector Comment

View of the overgrown vegetation along the landside slope.

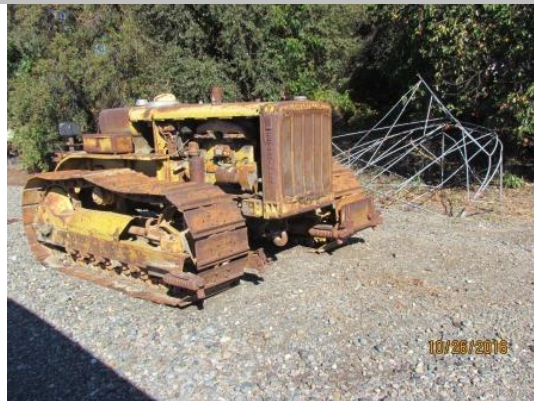
Photo 1 of 1 : FA\_2016\_ST0003\_264\_98\_20161104\_00132.jpg

LM Start	6.51	Rating **	M	Issue No.	98
LM End	6.51	Issue Type +	En	Location *	LS
Category	Earthen Levee			GPS Latitude/Longitude	
				Start	End
Item	Encroachments			39.225307 °	39.225307 °
				-121.998755 °	-121.998755 °
DWR ID	DWR_ST0003_01_f_2016_98				
Comment Code					
EQ : Equipment					
Inspector Comment

View of the ag equipment along the landside toe.

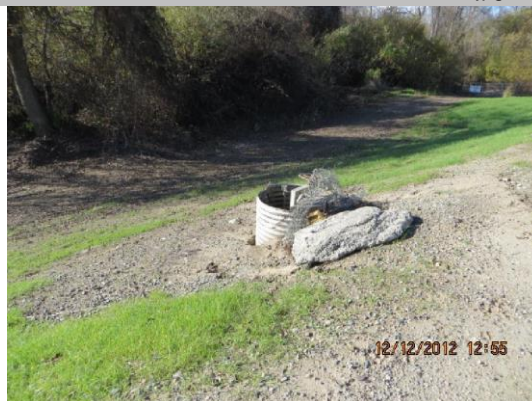
Photo 1 of 2 : UCIP\_FA\_2016\_50549\_47181.jpg

FS\_ID:50549  
DS\_ID:17296  
EP\_NO: 9530  
Repair Type: Non-Urgent  
Crossing Status: Indicator Found  
UCIP Comments: 10/31/2016 Abandoned. (DWR Sutter Yard-Afreitag)6/1/2016 Abandoned- only WS riser and screwgate found.4/1/2015 Only cmp riser with screwgate found on WS. Screwgate stem is bent.Appears abandoned and should be verified as having been done so properly. Only CMP riser with slide gate found on WS6/30/2014 Same as last inspection.12/18/2013 Same as last inspection.7/23/2013 Same as last inspection  
FIELD\_STRUCT\_DESC: \*ABANDONED\* 24-inch corrugated metal drainage pipe through the levee, 13.5 feet below the crown, not found in 2015. Slide gate in a corrugated metal pipe (CMP) riser on the waterside (WS) slope, found in 2015. (Automatic Board Order (ABO) issued as Permit No. 9530, 1974 - Halsey). [Additional Reference(s): DWR Levee Log, 2002. USACE Sacramento O&M Manual 136, March 1960 (HLM 6.61)].

Waterside view: CMP riser with slide gate

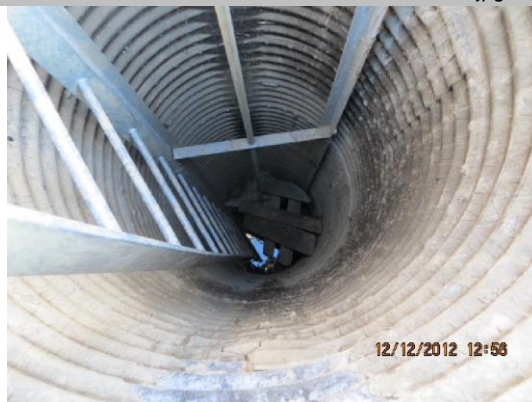
Photo 2 of 2 : UCIP\_FA\_2016\_50549\_47180.jpg

Waterside view: inside CMP riser

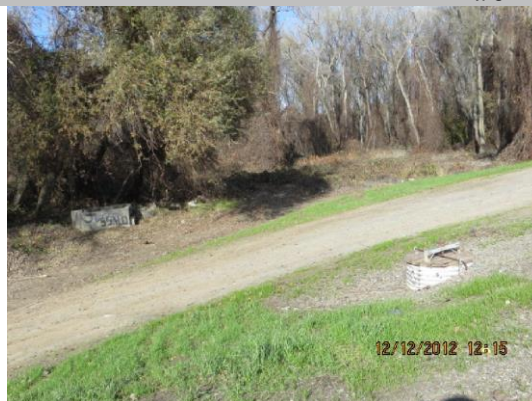
Photo 1 of 2 : UCIP\_FA\_2016\_50554\_47189.jpg

FS\_ID:50554  
DS\_ID:17300  
EP\_NO: N/A  
Repair Type: Non-Urgent  
Crossing Status: Indicator Found  
UCIP Comments: 10/31/2016 Abandoned (DWR Sutter Yard-Afreitag)6/1/2016 Abandoned4/1/2015 Only cmp riser and slide gate found on WS.Abandoned riser with slide gate on WS. Abandoned concrete surge box on WS. Verify pipe has been abandoned properly. 6/30/2014 Same as last inspection.12/18/2013 Same as last inspection.7/23/2013 Same as last inspection.  
FIELD\_STRUCT\_DESC: \*ABANDONED\* 24-inch corrugated metal drainage pipe through the levee, 14.5 feet below the crown, not found in 2015. Slide gate in a concrete surge box on the waterside (WS) berm, found in 2015. Slide gate in a corrugated metal pipe (CMP) riser, found in 2015. Pump on the WS slope, not found in 2015. [Additional Reference(s): DWR Levee Log, 2002. USACE Sacramento O&M Manual 136, March 1960 (HLM 7.61)].  
FS Date: 11/1/2016 12:16:12 PM

Waterside view: overview

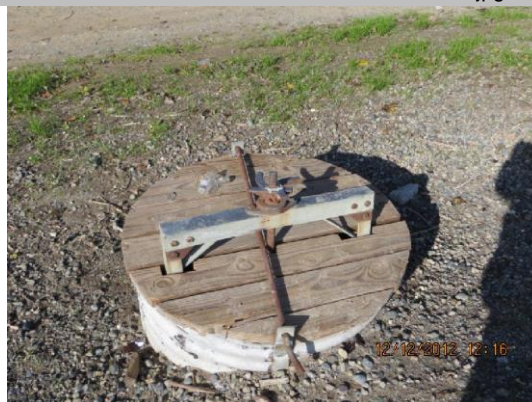
Photo 2 of 2 : UCIP\_FA\_2016\_50554\_47188.jpg

Waterside view: CMP riser with slide gate

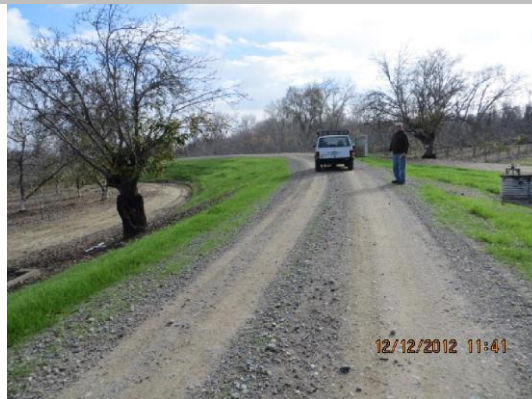
Photo 1 of 2 : UCIP\_FA\_2016\_50558\_47202.jpg

FS\_ID:50558  
DS\_ID:17304  
EP\_NO: 9529  
Repair Type: Non-Urgent  
Crossing Status: Found  
UCIP Comments: 10/31/2016 Abandoned (DWR Sutter Yard-Afreitag)6/1/2016 Abandoned- only WS riser and slide gate found.4/1/2015 CMP riser and slide gate on WS. LS distribution box is silted in. Looks abandoned. CMP riser with slide gate on WS. Concrete distribution box on LS- full with silt.6/30/2014 Same as last inspection.12/18/2013 Same as last inspection.7/23/2013 Same as last inspection.  
FIELD\_STRUCT\_DESC: \*ABANDONED\* 24-inch corrugated metal drainage pipe through the levee, invert 12.8 feet below the crown. Slide gate in a corrugated metal pipe (CMP) riser on the waterside (WS) slope. Concrete box at the landside (LS) toe. (Automatic Board Order (ABO) issued as Permit No. 9529, 1974 - Dorwood Ranching Company). [Additional Reference(s): DWR Levee Log, 2002. USACE Sacramento O&M Manual 136, March 1960 (HLM 8.35)].

Crown view: overview (both sides of the levee)

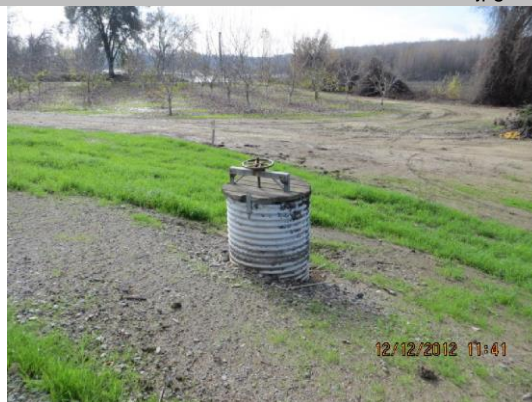
Photo 2 of 2 : UCIP\_FA\_2016\_50558\_47201.jpg

Waterside view: overview of CMP riser

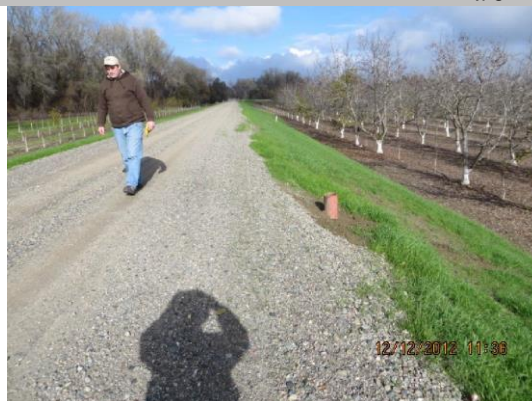
Photo 1 of 2 : UCIP\_FA\_2016\_50560\_47206.jpg

Comment Code					
Inspector Comment					
FS_ID:50560 DS_ID:17338 EP_NO: N/A Repair Type: Non-Urgent Crossing Status: Indicator Found UCIP Comments: 10/31/2016 Only the LS standpipe and airvent found.6/1/2016 Still only the vacuum breaker on LS shoulder visible.4/1/2015 Only vacuum breaker found on LS shoulder.6/30/2014 Same as last inspection.12/18/2013 Same as last inspection.7/23/2013 Same as last inspection. FIELD_STRUCT_DESC: Pipe of unknown diameter, purpose and material through the levee, at an unknown depth below the crown, not found. Vacuum breaker inside steel standpipe on the landside (LS) shoulder, found in 2015. [Additional Reference(s): DWR Levee Log, 2002]. FS Date: 11/1/2016 12:27:11 PM

Waterside view: overview

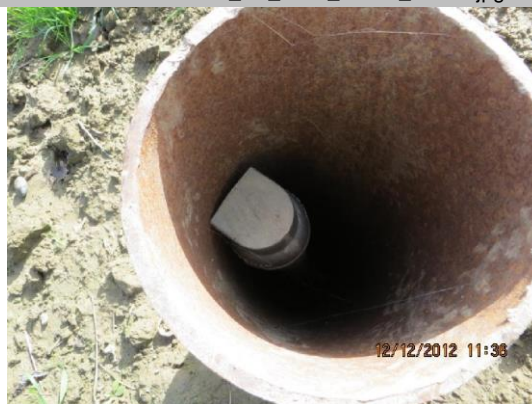
Photo 2 of 2 : UCIP\_FA\_2016\_50560\_47205.jpg

Waterside view: vacuum breaker inside a steel pipe

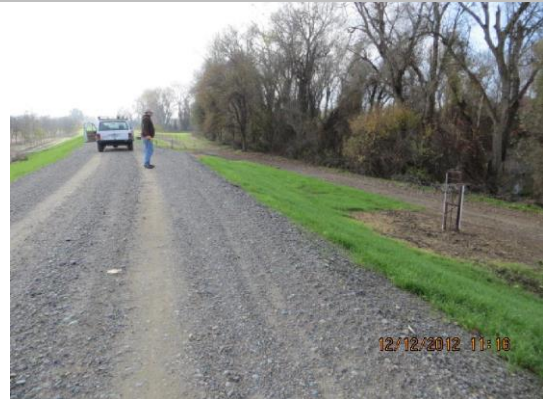
Photo 1 of 2 : UCIP\_FA\_2016\_50562\_47210.jpg

Comment Code					
Inspector Comment					
FS_ID:50562 DS_ID:17327 EP_NO: 9528 Repair Type: Non-Urgent Crossing Status: Found UCIP Comments: 10/31/2016 Abandoned. (DWR Sutter Yard-Afreitag)6/13/2016- Pipe was internally cleaned and camaera inspected by Nor-Cal Pipeline Services on 10/29/2015. Pipe length through levee is 75.1ft long. The inspection showed some signs of rust but no holes or other deterioration were found. Pics of exposed pipe ends were uploaded on 4/1/2015. After the inspection the pipe ends were capped and reburied.4/14/2016- Same as last inspection.4/1/2015- Both ends of pipe have been dug up in preparation for internal camera inspections. Pipe shows some rust but appears to be in decent shape. Only buried slide gate structure found.6/30/2014- Same as last inspection.12/18/2013 Same as last inspection.7/23/2013 Same as last inspection. FIELD_STRUCT_DESC: *ABANDONED* 24-inch corrugated metal drainage pipe through the levee, 12.5 feet below the crown. Slide gate on the waterside (WS). (Automatic Board Order (ABO) issued as Permit No. 9528, 1974 - Lamb). [Additional Reference(s): DWR Levee Log, 2002. USACE Sacramento O&M Manual 136, March 1960 (HLM 8.59)]. FS Date: 11/1/2016 1:06:31 PM

Waterside view: overview

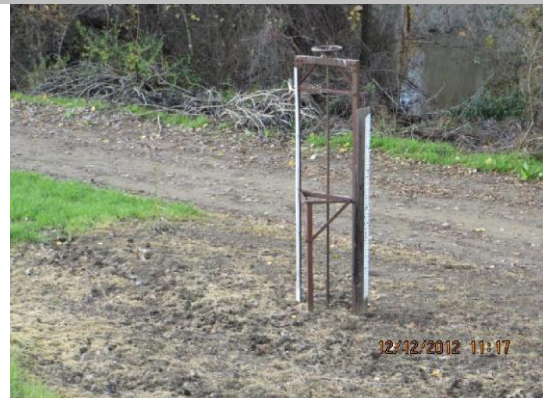
Photo 2 of 2 : UCIP\_FA\_2016\_50562\_47209.jpg

Waterside view: buried slide gate

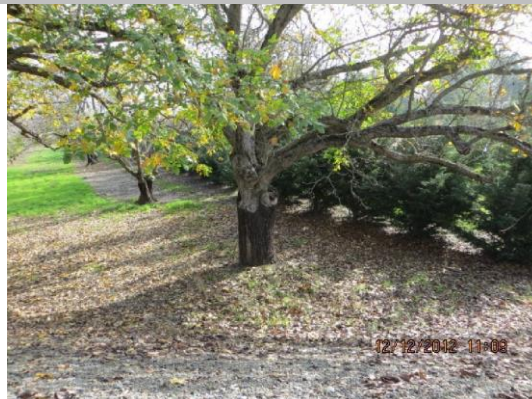
Photo 1 of 2 : UCIP\_FA\_2016\_50564\_74662.jpg

FS\_ID:50564  
DS\_ID:17352  
EP\_NO: 9523  
Repair Type: Non-Urgent  
Crossing Status: Indicator Found  
UCIP Comments: 10/31/2016 Abandoned. (DWR Sutter Yard-Afreitag)6/13/2016 Abandoned crossing.4/14/2016 Appears abandoned and if so, should be done so properly. Borrowing activity on landside (LS).8/28/2015 Pipe has been dug up and located along the WS levee toe.6/30/2014 Unable to locate.12/18/2013 Unable to locate.7/23/2013 Same as last inspection. Unable to locate.  
FIELD\_STRUCT\_DESC: \*ABANDONED\* 10-inch concrete encased steel drainage pipe through the levee, invert 15 feet below the crown, not found in 2016. Gate valve in a 42-inch corrugated metal pipe riser on the waterside (WS) slope, found in 2016. (Automatic Board Order (ABO) issued as Permit No. 9523, 1974 - Blackmore). Additional Reference(s): DWR Levee Log, 2002. USACE Sacramento O&M Manual 136, March 1960 (HLM 8.7)].  
FS Date: 11/1/2016 1:16:56 PM

View of LS

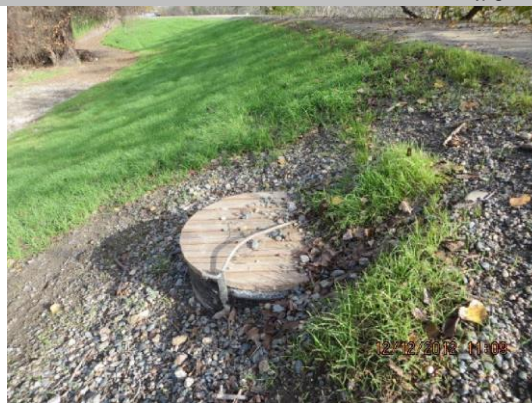
Photo 2 of 2 : UCIP\_FA\_2016\_50564\_74661.jpg

42-inch riser on WS shoulder.

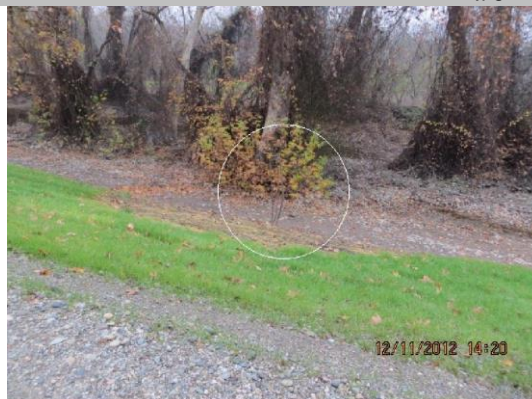
Photo 1 of 2 : UCIP\_FA\_2016\_50565\_47216.jpg

FS\_ID:50565  
DS\_ID:17353  
EP\_NO: 4491  
Repair Type: Urgent  
Crossing Status: Found  
UCIP Comments: 10/31/2016 Pipe still exposed along the WS toe and is rusted and corroded. If it is still in use by the owner then it should be rebuilt.(DWR Sutter Yard- Afreitag)6/13/2016 Pipe was dug up on WS and photographed. It was originally selected for internal inspection but was unable to be as there was no access to the inside of the 4" pipe. (DWR Sutter Yard - afreitag)4/14/2016 Signs of corrosion on pipe and valve on LS. Pipe in use according to Bryan Reniff of Sutter Yard. (DWR UCIP - kfazel)8/28/2015 Pipe was dug up and located on the WS levee toe. (DWR Sutter Yard - afreitag)6/30/2014 Same as last inspection. (DWR Sutter Yard - afreitag)12/18/2013 Same as last inspection. (DWR Sutter Yard - afreitag)7/23/2013 Same as last inspection. (DWR Sutter Yard - afreitag)12/11/2012 Only abandoned slide gate found on WS. (DWR UCIP - pamatya)

Waterside view: overview of slide gate on steel structure (belongs to crossing at CLM-8.782)

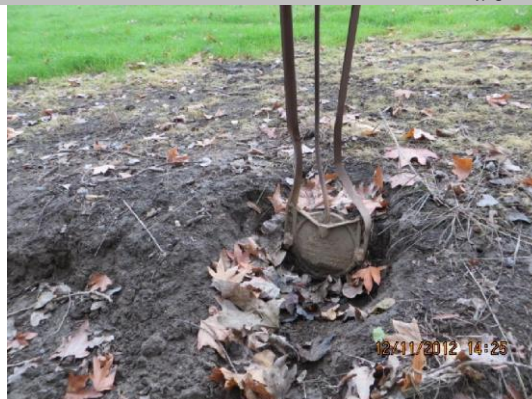
Photo 2 of 2 : UCIP\_FA\_2016\_50565\_47215.jpg

Waterside view: slide gate on steel structure (belongs to crossing at CLM-8.782)

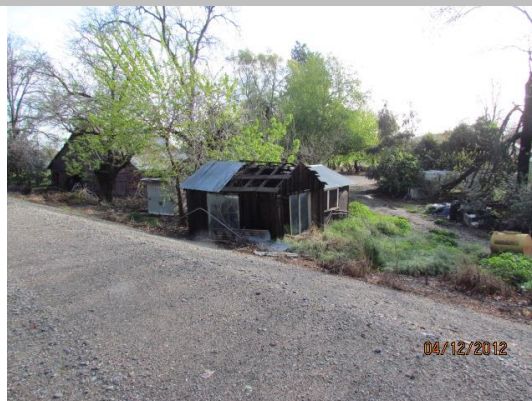
Photo 1 of 1 : FA\_2016\_ST0003\_264\_2\_20160823\_00002.jpg

LM Start	8.75	Rating **	U	Issue No.	2
LM End	8.75	Issue Type +	En	Location *	LS
Category	Earthen Levee			GPS Latitude/Longitude	
				Start	End
Item	Encroachments			39.252260 °	39.252260 °
				-121.997721 °	-121.997721 °
DWR ID	DWR_ST0003_01_s _ 2012_2				
Comment Code					
BU : Building					
Inspector Comment

View of the building next to the toe of the levee.

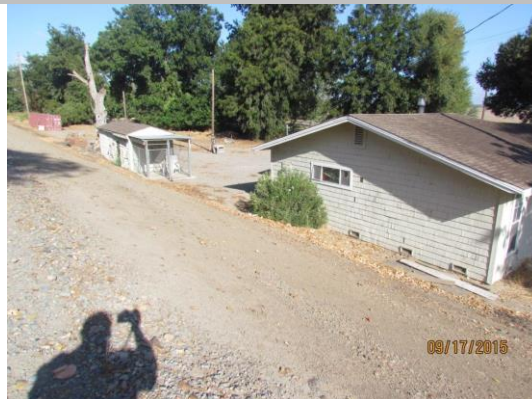
Photo 1 of 1 : FA\_2016\_ST0003\_264\_4\_20160823\_00003.jpg

LM Start	10.27	Rating **	M	Issue No.	4
LM End	10.27	Issue Type +	En	Location *	LS
Category	Earthen Levee			GPS Latitude/Longitude	
				Start	End
Item	Encroachments			39.270431 °	39.270431 °
				-121.999782 °	-121.999782 °
DWR ID	DWR_ST0003_01_s _ 2012_4				
Comment Code					
BU : Building					
Inspector Comment

View of the house and dog kennel at the landside toe.

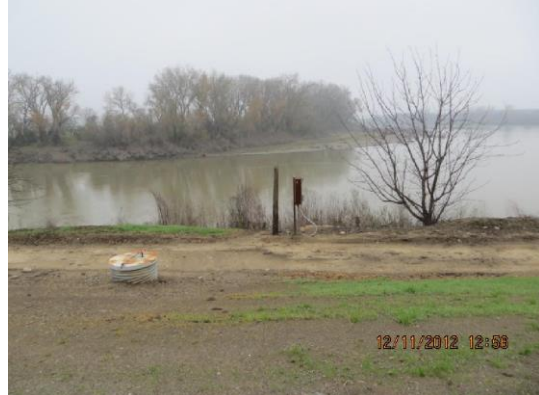
Photo 1 of 2 : UCIP\_FA\_2016\_50571\_47270.jpg

FS\_ID:50571  
DS\_ID:17371  
EP\_NO: 9517  
Repair Type: Non-Urgent  
Crossing Status: Found  
UCIP Comments: 10/31/2016 Abandoned. (DWR Sutter Yard-Afreitag)6/1/2016 Abandoned crossing.4/2/2015 Same as last inspection. Need to verify type of abandonment. Pump house not found on waterside of the levee. Looks abandoned as switch panel found without pump.6/30/2014 Same as last inspection.12/18/2013 Same as last inspection.7/23/2013 Same as last inspection.  
FIELD\_STRUCT\_DESC: \*ABANDONED\* 18-inch steel irrigation pipe through the levee, 17.1 feet below the crown. Gate valve and flap gate in a concrete distribution box. Water meter in a corrugated metal pipe (CMP) riser at the landside (LS) toe. Gate valve in a CMP on the waterside (WS). Pipe was replaced in November 2005. (Automatic Board Order (ABO) issued as Permit No. 9517, 1974 - Griffin).  
[Additional Reference(s): DWR Levee Log, 2002. USACE Sacramento O&M Manual 136, March 1960 (HLM 10.53)].

Waterside view: CMP riser and abandoned service pole

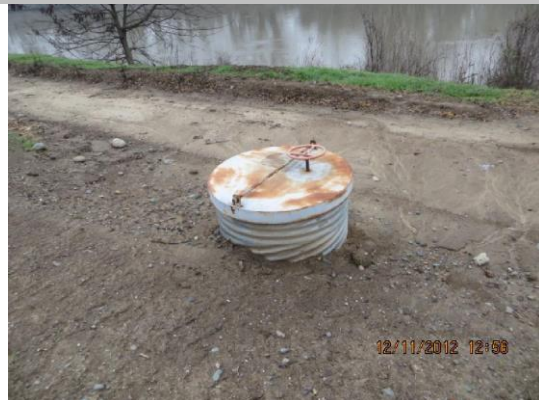
Photo 2 of 2 : UCIP\_FA\_2016\_50571\_47269.jpg

Waterside view: CMP riser with gate valve

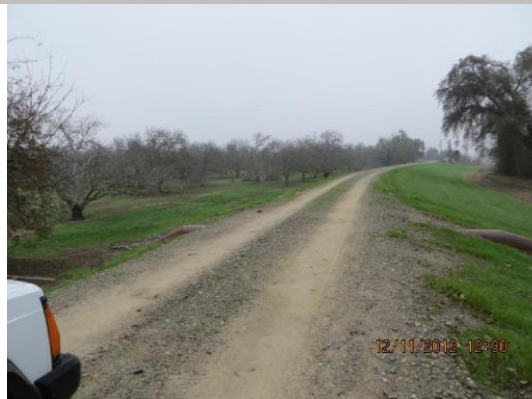
Photo 1 of 2 : UCIP\_FA\_2016\_50573\_47284.jpg

FS\_ID:50573  
DS\_ID:17350  
EP\_NO: 1369  
Repair Type: Non-Urgent  
Crossing Status: Found  
UCIP Comments: 10/31/2016 Appears abandoned. (DWR Sutter Yard-AFreitag)6/1/2016 Appears to be an abandoned crossing.4/2/2015 Same as last inspection. Looks abandoned and if so should be done so properly. Pump and switch panel not found. Outlet pipe blocked by silt and debris.6/30/2014 Same as last inspection.12/18/2013 Same as last inspection.7/23/2013 Same as last inspection.  
FIELD\_STRUCT\_DESC: \*ABANDONED\* 24-inch steel irrigation pipe through the levee, 4 feet below the crown. Siphon breaker on the landside (LS) slope. Concrete distribution box on the LS toe. (Permit No. 1369, 1949 - Griffin). [Additional Reference(s): DWR Levee Log, 2002. USACE Sacramento O&M Manual 136, March 1960 (HLM 10.68)].  
FS Date: 11/2/2016 8:38:10 AM

Crown view: overview (both sides of the levee)

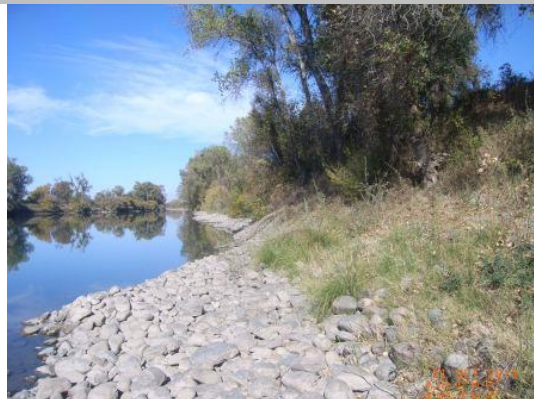
Photo 1 of 1 : FA\_2016\_ST0003\_264\_8\_20160823\_00004.jpg

LM Start	11.53	Rating **	M	Issue No.	8
LM End	11.79	Issue Type +	Ma	Location *	WS
Category	Supplemental			GPS Latitude/Longitude	
				Start	End
Item	2015 USACE Erosion Survey, DRAFT			39.279910 °	39.283853 °
				-122.018221 °	-122.016113 °
DWR ID	DWR_ST0003_01_s _ 2016_8				
Comment Code					
Inspector Comment					
2008 - Large rotational/mass failure in the bank with tree slump. 2009 - Minimal new erosion, the tree is leaning further into the river. 2011 - Site extended downstream. 2012 - Minor new erosion and tree roots are further exposed. 2015: Last observed in 2013. [2015 Site ID: SAC_152-6_L]

USACE 2013 Photo #1

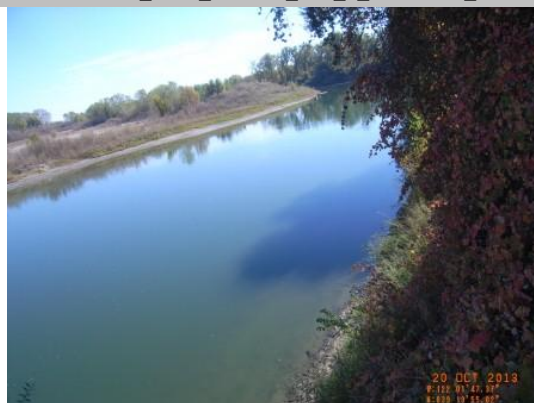
Photo 1 of 1 : FA\_2016\_ST0003\_264\_1\_20160823\_00001.jpg

LM Start	11.85	Rating **	M	Issue No.	1
LM End	11.90	Issue Type +	Ma	Location *	WS
Category	Supplemental			GPS Latitude/Longitude	
				Start	End
Item	2015 USACE Erosion Survey, DRAFT			39.331447 °	39.332716 °
				-122.029440 °	-122.029953 °
DWR ID	DWR_ST0003_01_s _ 2016_1				
Comment Code					
Inspector Comment					
2004 - Slowly eroding but near vertical with no vegetation to hold it.					
2005 - Erosion is close to levee toe but not into the levee section yet.					
2010 - Some new toe scour. 2015: Last observed in 2013. [2015 Site ID: SAC_157-7_R]

USACE 2013 Photo #1

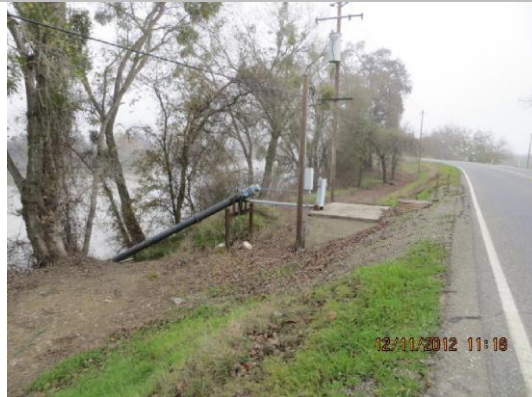
Photo 1 of 2 : UCIP\_FA\_2016\_50579\_47306.jpg

FS\_ID:50579  
DS\_ID:17365  
EP\_NO: 9514  
Repair Type: Non-Urgent  
Crossing Status: Found  
UCIP Comments: 10/31/2016 Crossing appears to be in good condition.(DWR Sutter Yard- A Freitag)6/6/2016 Crossing appears to be in good condition. New wooden cover was made for WS surge tank.4/2/2015 Everything looked to be in good condition. Concrete surge tank still has some silting. Gate valve in CMP riser not visible. Flap gate in concrete distribution box on LS not visible/accessibile. Looks like cleaning required inside concrete surge tank on WS due to silting.7/2/2014 Same as last inspection.12/30/2013 Same as last inspection.7/29/2013 Pump running and WS surge tank was full of water so not sure if silt was cleaned out. LS flap gate was visible and is in good condition.  
FIELD\_STRUCT\_DESC: 36-inch corrugated metal irrigation pipe through the levee, 18.1 feet below the crown. Pump house on the waterside (WS) slope. Gate valve in a corrugated metal riser on the WS toe. Flap gate in a concrete distribution box at the landside (LS) toe. (Automatic Board Order (ABO) issued as Permit No. 9514, 1974 - Boggs). [Additional Reference(s): Levee Log, 2002. USACE Sacramento O&M Manual 136, March 1960 (HLM 12.05)].

Waterside view: overview pipe, pump, surge box & CMP riser

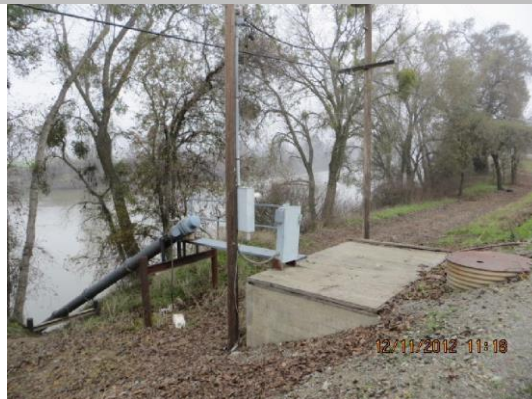
Photo 2 of 2 : UCIP\_FA\_2016\_50579\_47305.jpg

Waterside view: steel pipe, pump, surge box & CMP riser

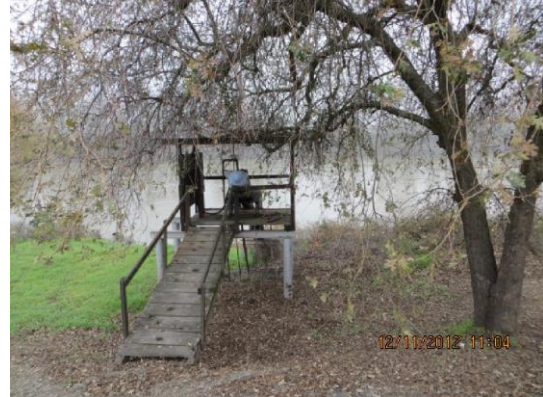
Photo 1 of 2 : UCIP\_FA\_2016\_50580\_47313.jpg

FS\_ID:50580  
DS\_ID:17366  
EP\_NO: 9513  
Repair Type: Urgent  
Crossing Status: Found  
UCIP Comments: 10/31/2016 2.5in. pipe still blocking the screwgate. (DWR Sutter Yard- AFreitag)6/6/2016 2.5inch pipe still present through crossing. (DWR Sutter Yard - afreitag)4/14/2016 2.5-inch pipe still preventing slide gate from fully closing on WS. Recommend LMA contact owner to address removal of unauthorized 2.5-inch pipe. Owner must either contact CVFPB for permitting of 2.5-inch pipe or remove it. (DWR UCIP - kfazel)4/2/2015 2.5in pipe is still present and prevents the slide gate from fully closing. (DWR Sutter Yard - afreitag)7/2/2014 2.5in. GI pipe and chain in WS surge box will prevent slide gate from closing fully for high water season. (DWR Sutter Yard - afreitag)12/30/2013 Same as last inspection. (DWR Sutter Yard - afreitag)7/29/2013 2.5in. GI pipe and chain in WS surge box will prevent slide gate from closing fully for high water season. (DWR Sutter Yard - afreitag)12/11/2012 A 2.5 inch GI pipe through 36 inch CMP found. A 2 inch electrical conduit also found. (DWR UCIP - pamatya)

FIELD\_STRUCT\_DESC: 24-inch corrugated metal irrigation pipe through the levee, invert 16.5 feet below the crown. Slide gate in a concrete surge box on the waterside (WS) berm. 2.5-inch pipe through the 24-inch pipe preventing closing of the slide gate on the WS. Slant pump on the riverbank. Concrete distribution box at the landside (LS) toe. 2-inch electrical conduit through the levee, visible on the WS adjacent to the walkway. (Automatic Board Order (ABO) issued as Permit No. 9513, 1974 - Boggs). [Additional Reference(s): DWR Levee Log, 2002. USACE Sacramento O&M Manual 136, March 1960 (HLM 12.42)].  
FS Date: 11/2/2016 8:55:09 AM

Waterside view: overview of slanted pump and shed

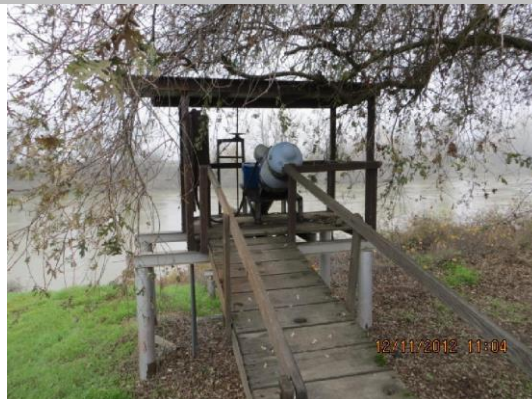
Photo 2 of 2 : UCIP\_FA\_2016\_50580\_47312.jpg

FS\_ID:50580  
DS\_ID:17366  
EP\_NO: 9513  
Repair Type: Urgent  
Crossing Status: Found  
UCIP Comments: 10/31/2016 2.5in. pipe still blocking the screwgate. (DWR Sutter Yard- AFreitag)6/6/2016 2.5inch pipe still present through crossing. (DWR Sutter Yard - afreitag)4/14/2016 2.5-inch pipe still preventing slide gate from fully closing on WS. Recommend LMA contact owner to address removal of unauthorized 2.5-inch pipe. Owner must either contact CVFPB for permitting of 2.5-inch pipe or remove it. (DWR UCIP - kfazel)4/2/2015 2.5in pipe is still present and prevents the slide gate from fully closing. (DWR Sutter Yard - afreitag)7/2/2014 2.5in. GI pipe and chain in WS surge box will prevent slide gate from closing fully for high water season. (DWR Sutter Yard - afreitag)12/30/2013 Same as last inspection. (DWR Sutter Yard - afreitag)7/29/2013 2.5in. GI pipe and chain in WS surge box will prevent slide gate from closing fully for high water season. (DWR Sutter Yard - afreitag)12/11/2012 A 2.5 inch GI pipe through 36 inch CMP found. A 2 inch electrical conduit also found. (DWR UCIP - pamatya)

Waterside view: pump station and walkway

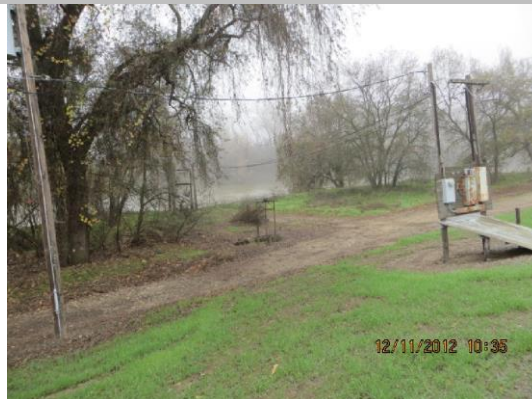
Photo 1 of 2 : UCIP\_FA\_2016\_50582\_47323.jpg

FIELD\_STRUCT\_DESC: 36-inch corrugated metal irrigation pipe through the levee, 20 feet below the crown. Concrete headwall on the landside (LS) with meter. Slide gate on the waterside (WS) end. Two slant pumps on the WS bank discharging into a concrete distribution box at the WS toe. Switch panel on the WS. (Permit No. 2971, 1959 - Sartain). [Additional Reference(s): DWR Levee Log, 2002. USACE Sacramento O&M Manual 136, March 1960 (HLM 12.55)].  
FS Date: 11/2/2016 8:57:24 AM

Waterside view: overview

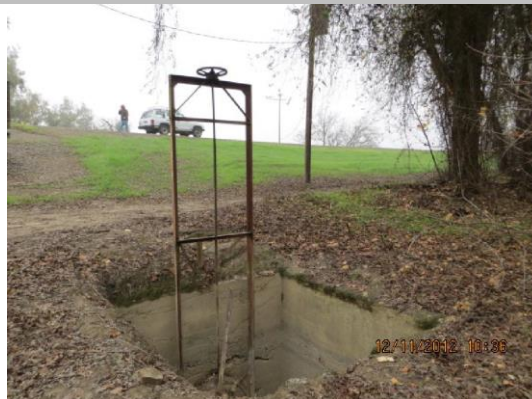
Photo 2 of 2 : UCIP\_FA\_2016\_50582\_47322.jpg

FIELD\_STRUCT\_DESC: 36-inch corrugated metal irrigation pipe through the levee, 20 feet below the crown. Concrete headwall on the landside (LS) with meter. Slide gate on the waterside (WS) end. Two slant pumps on the WS bank discharging into a concrete distribution box at the WS toe. Switch panel on the WS. (Permit No. 2971, 1959 - Sartain). [Additional Reference(s): DWR Levee Log, 2002. USACE Sacramento O&M Manual 136, March 1960 (HLM 12.55)].  
FS Date: 11/2/2016 8:57:24 AM

Waterside view: concrete surge box

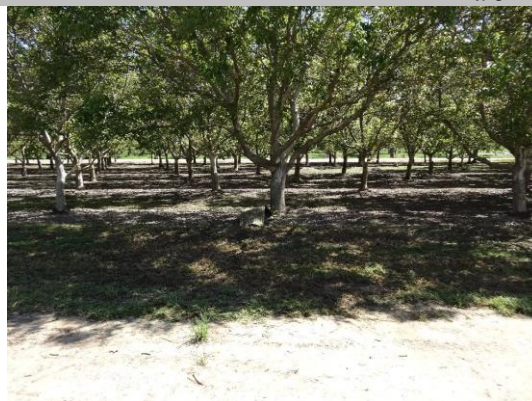
Photo 1 of 2 : UCIP\_FA\_2016\_50583\_75075.jpg

FS\_ID:50583  
DS\_ID:17368  
EP\_NO: N/A  
Repair Type: Non-Urgent  
Crossing Status: Indicator Found  
UCIP Comments: 10/31/2016 Appears abandoned. (DWR Sutter Yard-AFreitag)6/14/2016 Pipe was internally cleaned and camera inspected on 11/5/2015 by Nor-Cal Pipeline Services. Pipe length is 86.7ft long. The is a possible sag in the pipe between the WS riser and LS end as we could not get all the water to drain or be sucked out after the cleaning was done. Internal inspection showed signs of some rusting but no visible holes or other deterioration were found. After the inspection pipe ends were capped and reburied. 4/14/2016 Same as last inspection. Heavy vegetation along WS slope, especially below WS berm, limits visibility.4/2/2015 WS and LS pipe ends have been dug up in preparation for internal camera inspections. Only CMP riser found.7/2/2014 Same as last inspection.12/19/2013 Same as last inspection.7/23/2013 Same as last inspection.

FIELD\_STRUCT\_DESC: \*ABANDONED\* 12-inch drainage pipe of an unknown material through the levee, 14 feet below the crown, not found in 2016. Slide gate in a corrugated metal pipe riser (CMP) on the waterside (WS) slope, found in 2016. [Additional Reference(s): DWR Levee Log, 2002. USACE Sacramento O&M Manual 136, March 1960 (HLM 12.73)].  
FS Date: 11/2/2016 8:59:24 AM

View of landside from crown.

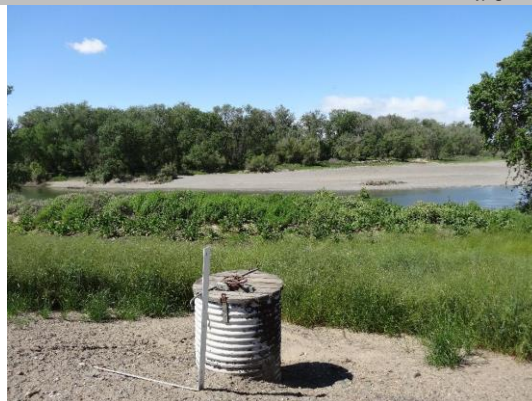
Photo 2 of 2 : UCIP\_FA\_2016\_50583\_75076.jpg

WS view: 12-inch slide gate inside CMP riser on WS slope.

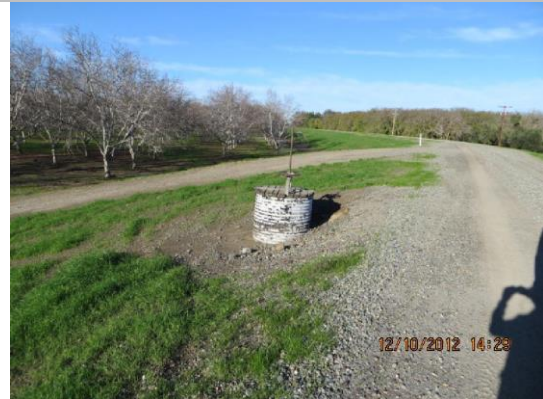
Photo 1 of 2 : UCIP\_FA\_2016\_50584\_47336.jpg

Comment Code					
Inspector Comment					
FS_ID:50584 DS_ID:17369 EP_NO: 9510 Repair Type: Urgent Crossing Status: Found UCIP Comments: 10/31/2016 No repairs have been made here yet. Bad erosion stil present at the WS toe distridution box.(DWR Sutter Yard- AFreitag)6/3/2016 Bad erosion stil present all around the WS surge box. Pipes were flowing water at the time of inspection and the bottom of the erosion hole was wet and had standing water in it indicating a leak coming from the surge box. (DWR Sutter Yard - afreitag)4/14/2016 Heavy scour still present around surge box on WS exposing pipe. Levee caved in and severely damaged around surge box. Erosion around CMP riser on WS cited previously not found. (DWR UCIP - kfazel)4/2/2015 Pipe leaks during high water. It is suspected that the screw gate does not fully close and may need to be cleaned to allow it to close fully. (DWR Sutter Yard - afreitag)7/2/2014 Same as last inspection. (DWR Sutter Yard - afreitag)12/19/2013 Same as last inspection. (DWR Sutter Yard - afreitag)7/23/2013 Water was flowing from the WS to LS ditch. Not sure where water flow was originating. All erosion problems are still present. (DWR Sutter Yard - afreitag)12/10/2016 Soil erosion around CMP riser and surge concrete box on WS damaged due to overflow. Pump not found. Flap gate missing on WS concrete box. WS slope eroded. Structure might have been used as drainage structure. This needs to be determined during routine inspection. (DWR UCIP - pamatya) FIELD_STRUCT_DESC: 36-inch corrugated metal irrigation pipe through the levee, 18 feet below the crown. Slide gate in a 48-inch corrugated metal pipe (CMP) riser on the waterside (WS) slope. Concrete box on the WS. Pump mounted on the WS bank, not found in 2016. (Automatic Board Order (ABO) issued as Permit No. 9510, 1974 - Forry). [Additional Reference(s): DWR Levee Log, 2002. USACE Sacramento O&M Manual 136, March 1960 (HLM 12.95)]. FS Date: 11/2/2016 9:03:02 AM

Waterside view: CMP riser on levee slope.
